Manhole Inspection Summary

Manhole # S150O1030MH

Insp Date: **11/30/06 1:07 PM**

Location Address: **2600 WOODLAND AVE**

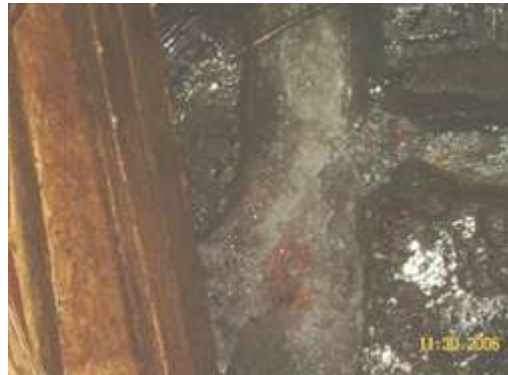
Top View

Evidence of surcharge - Bench debris.

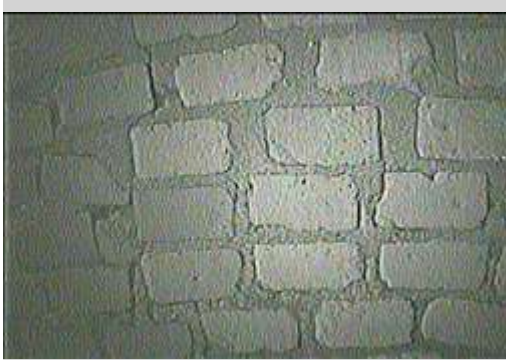
Defect

Barrel cracks and infiltration.

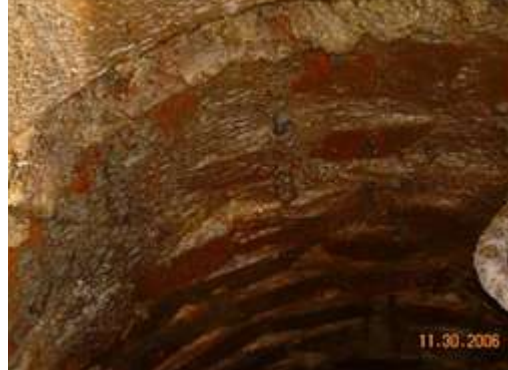
Defect

☒ **Leaks**

Infiltration: ☐ None ☒ **Joint** ☐ Cracks ☒ **Mortar** ☐ Roots ☐ Wall

Frame leaks. Adjustment and Corbel infiltration.

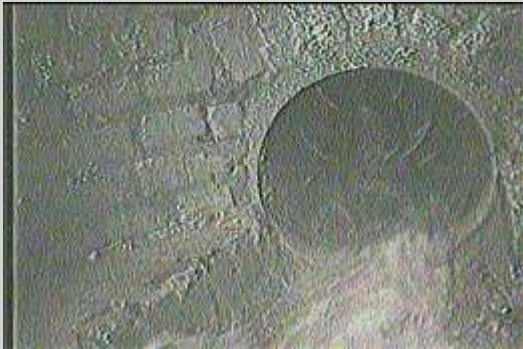
15 in. Circular Gravity Sewer Pipe Out @ 12 O'Clock

Infiltration: **None** Pipe Seal Cond: **Cracked**

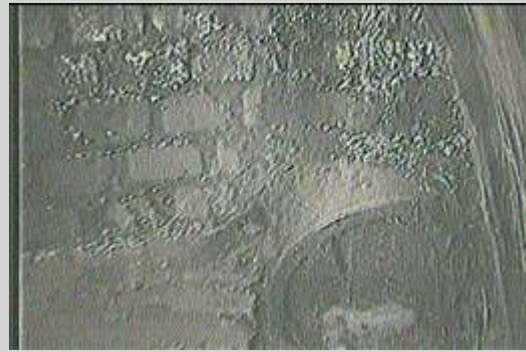
Drop In @ 6 O'Clock

Drop: **Outside** Rod and Bar
Angled: **Yes** Reading: **12.41** (ft.)
Inv Depth: **13.41** (ft.)
Drop Condition: **Partly Clogged**

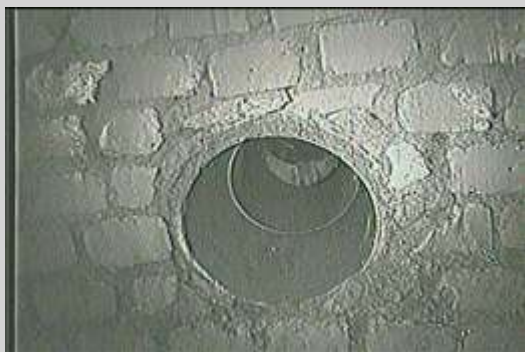
Pipe In @ 8 O'Clock

Infiltration: **None** Pipe Seal Cond: **Cracked**
